SCOTTISH RITE ASSOCIATION LODGE 1685 W 13TH AV EUGENE OR

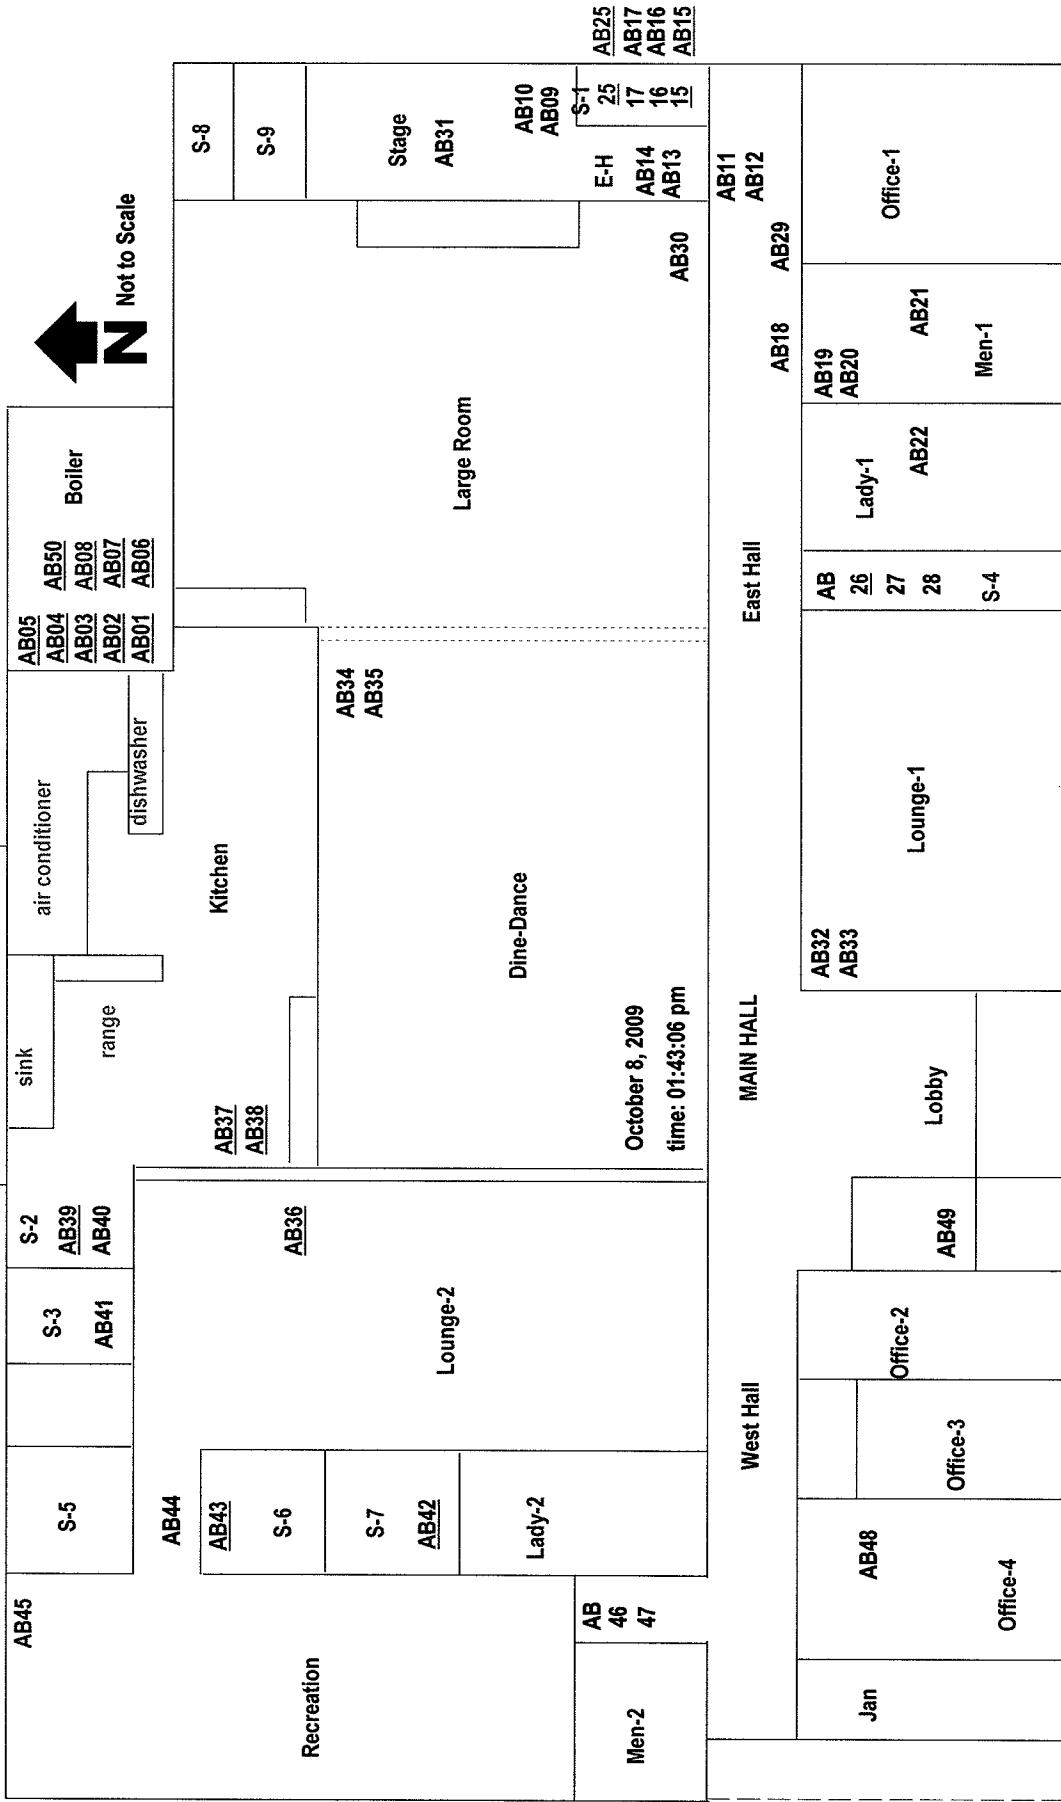
AB23-24

AB51-52 Red samples denote asbestos
Blue samples denote Trace asbestos
Black samples denote non-asbestos
